**TRANSPORTATION SCIENCES CENTER  
ACCIDENT RESEARCH GROUP**

**CALSPAN ON-SITE AIR BAG DEPLOYMENT INVESTIGATION  
CALSPAN CASE NO. 95-16  
VEHICLE: 1995 FORD ESCORT LX, STATION WAGON  
LOCATION: [REDACTED] PA  
DATE OF CRASH: [REDACTED] 1995**

Contract No. DTNH22-94-D-07058

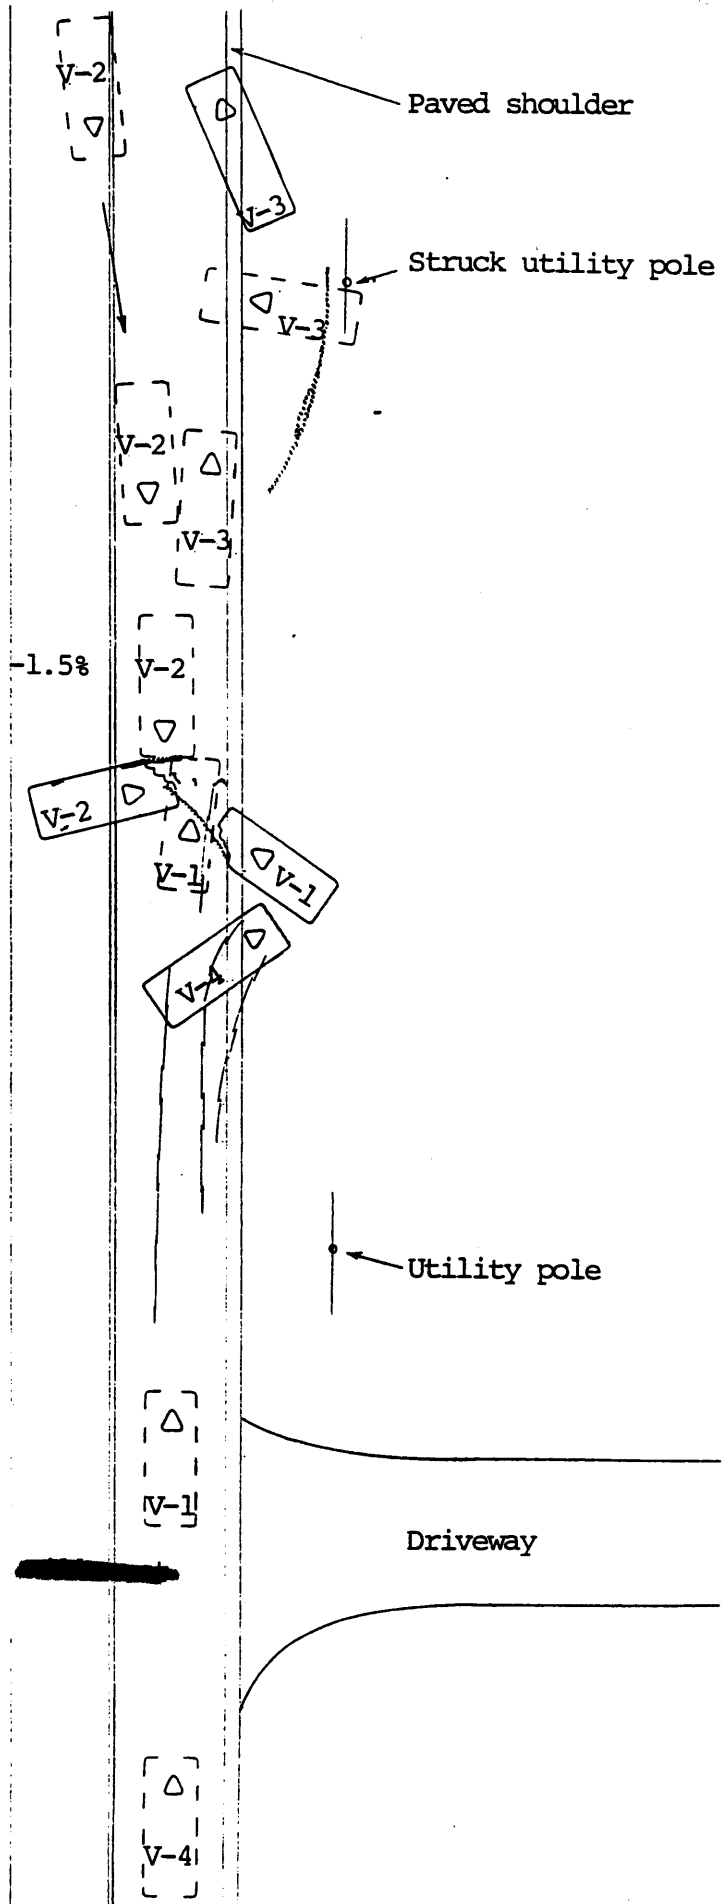
- #1 = 1995 Ford Escort LX,  
station wagon
- #2 - 1991 Toyota Camry,  
4-dr. sedan
- #3 - 1987 Buick LeSabre,  
4-dr. sedan
- #4 - 1982 Chevrolet Monte Carlo,  
2-dr. sedan

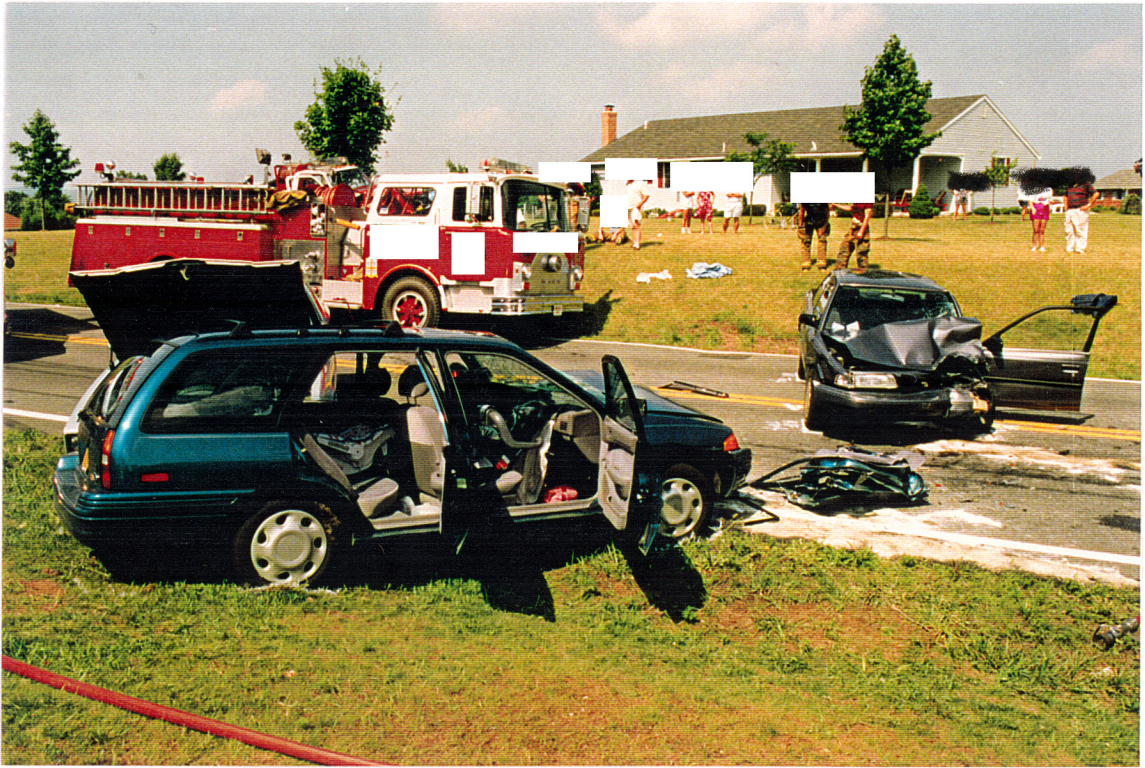
7. Overall view of the Ford Escort and the child restraint in the right front seated position.

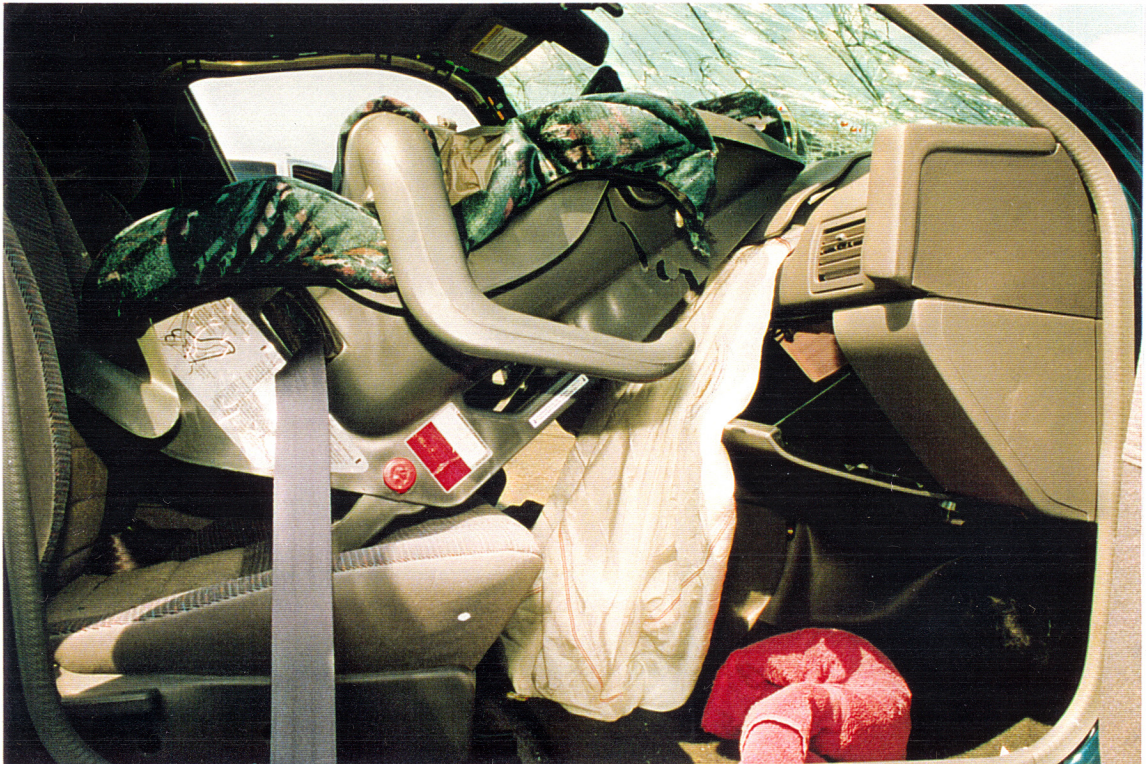
8. Close-up view of the probable final rest position of the Cosco Touriva child restraint in the right front position of the Ford escort.

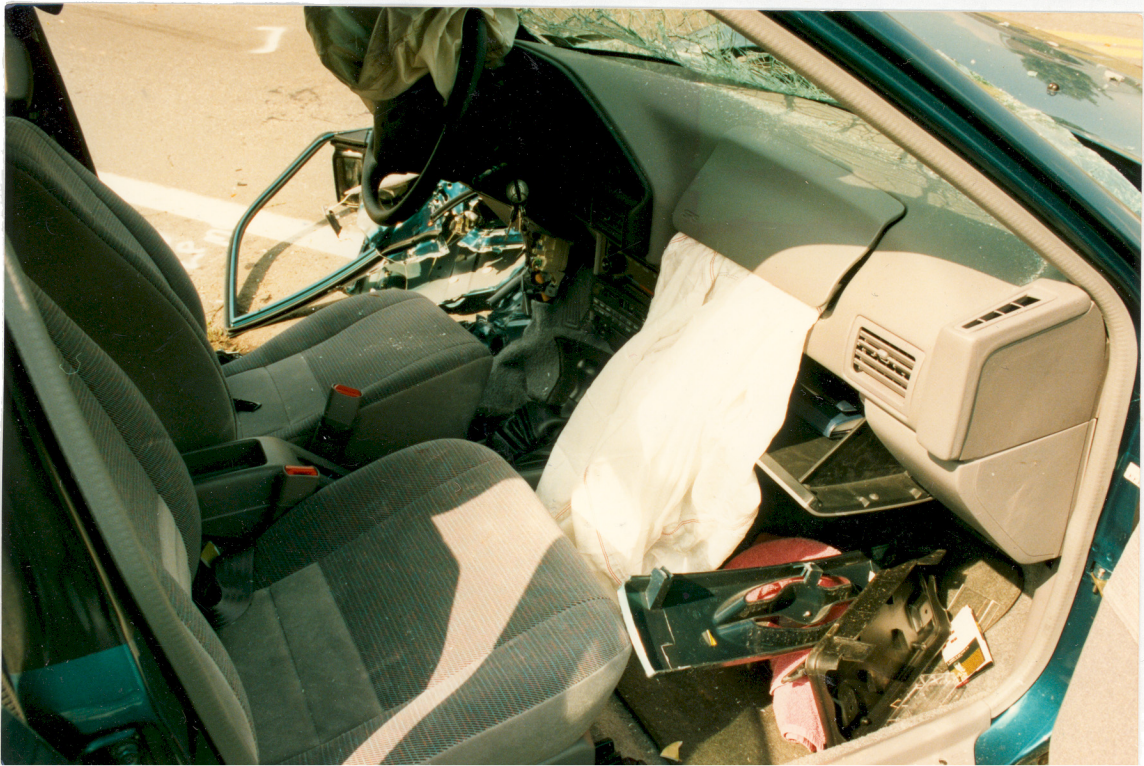
9. Deployed passenger side air bag with child restraint removed from vehicle.

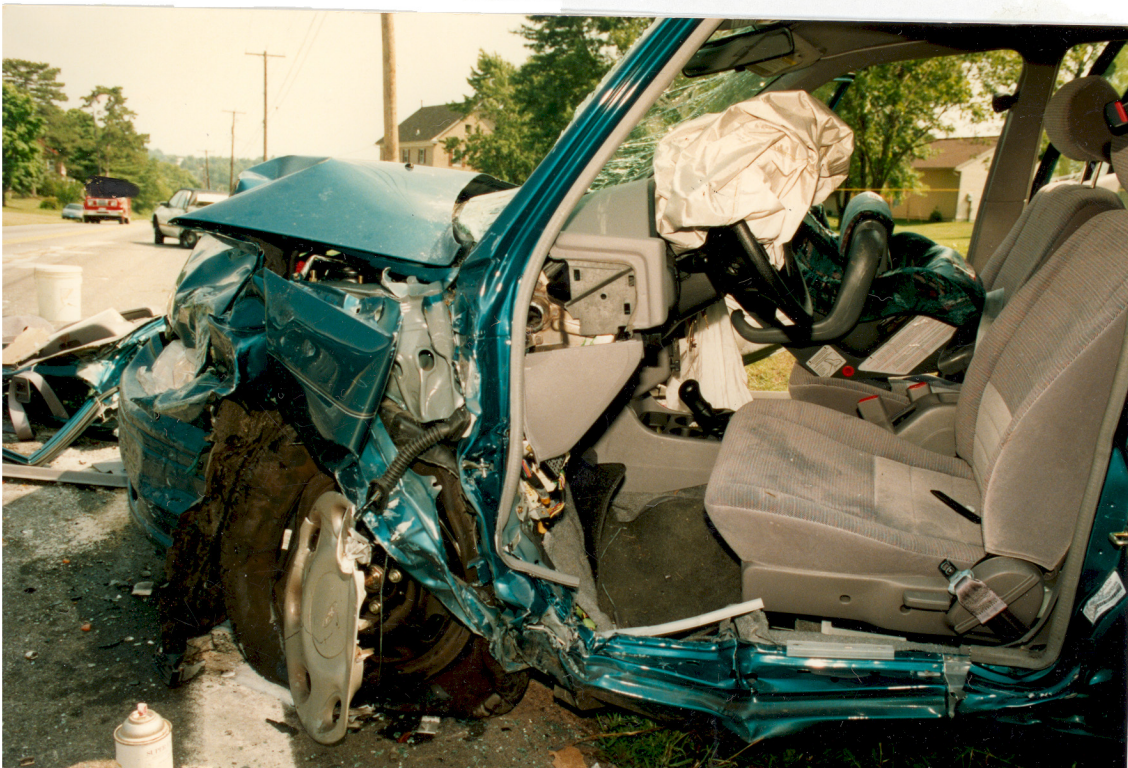
10. Overall view of the driver's position and deployed driver's side air bag.

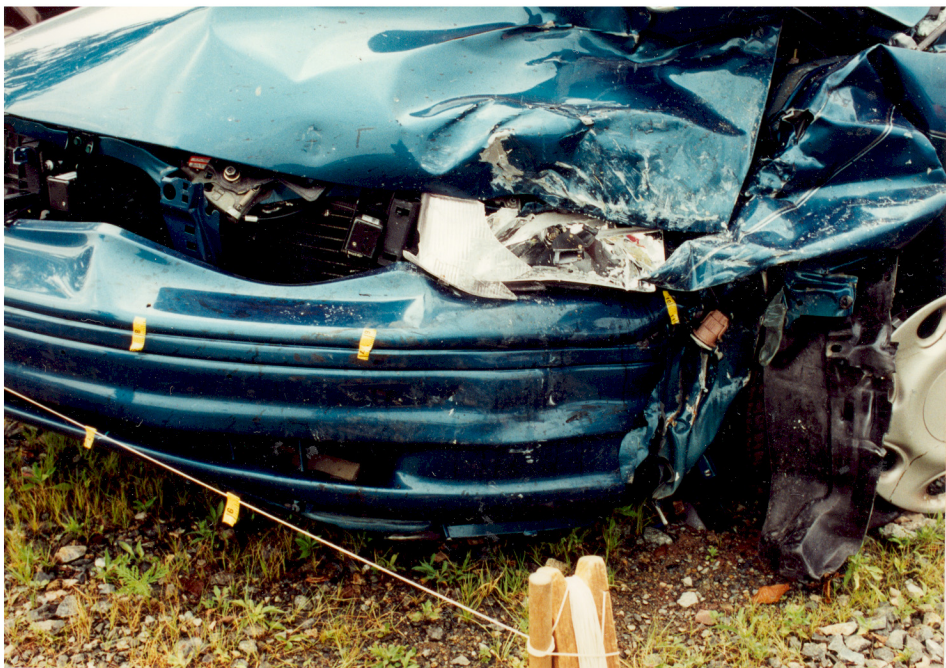
The left frontal area of the Toyota impacted the left front corner of the Ford Escort in an off-set head-on configuration. The resultant directions of force were within the 12 o'clock sector for both vehicles. The direct contact damage on the Toyota, which overlapped the initial impact sequence with the Buick, began 23.5 cm (9.25") right of center and extended 97.2 cm (38.25") to the left front corner. Maximum crush was 67.8 cm (26.7") located at the left corner of the front bumper. The Ford Escort sustained 74.3 cm (29.25") of maximum crush located at the left front bumper corner. The direct contact damage on the Escort began 19.3 cm (7.6") left of center and extended 57.2 cm (22.5") to the left bumper corner. The damage and trajectory algorithm of the CRASHPC program output computed total velocity changes of 33 km/h (21 mph) for the Ford Escort and 31 km/h (19 mph) for the Toyota Camry. As a result of the impact induced deceleration, the Ford Escort's supplemental driver and passenger side air bag system deployed.

20. Close-up view of the direct contact damage on the bumper facia.

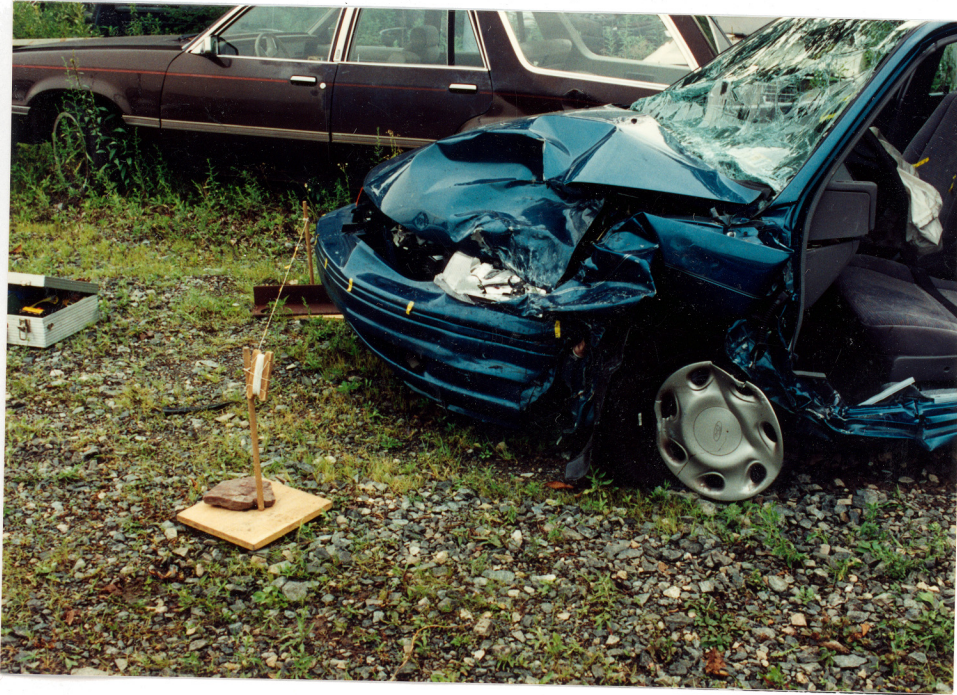
The damage was concentrated over the left headlamp area and involved compression of the left front structural members. Significant damage occurred to the left tire and wheel assembly which resulted in 34.3 cm (13.5") of rearward displacement of the left front axle position.

23. & 24. Perpendicular views documenting the extent of frontal crush.

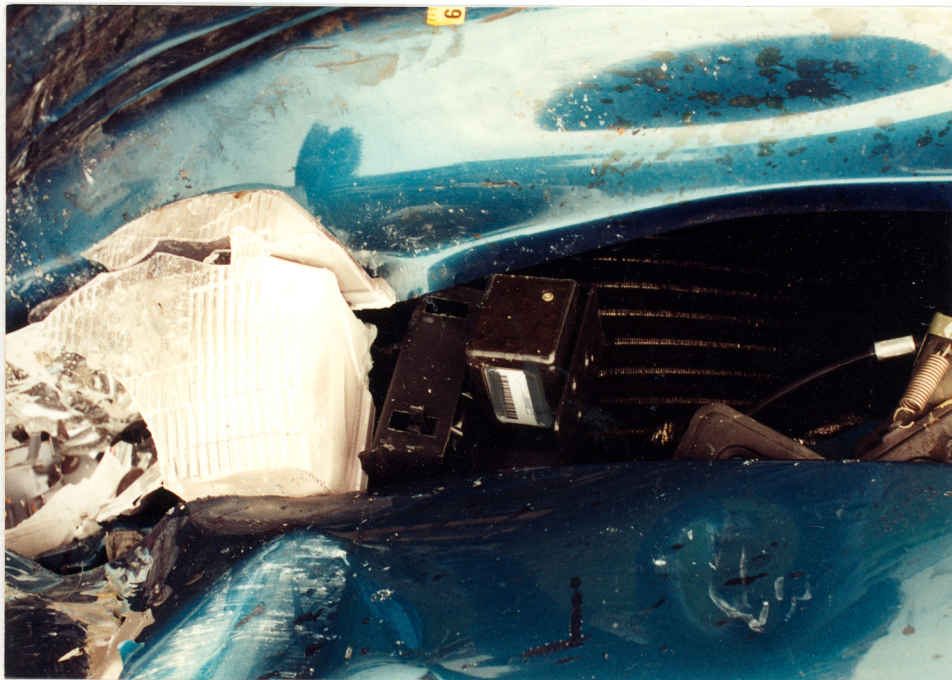
32. Left side air bag crash sensor, slightly damaged and displaced.

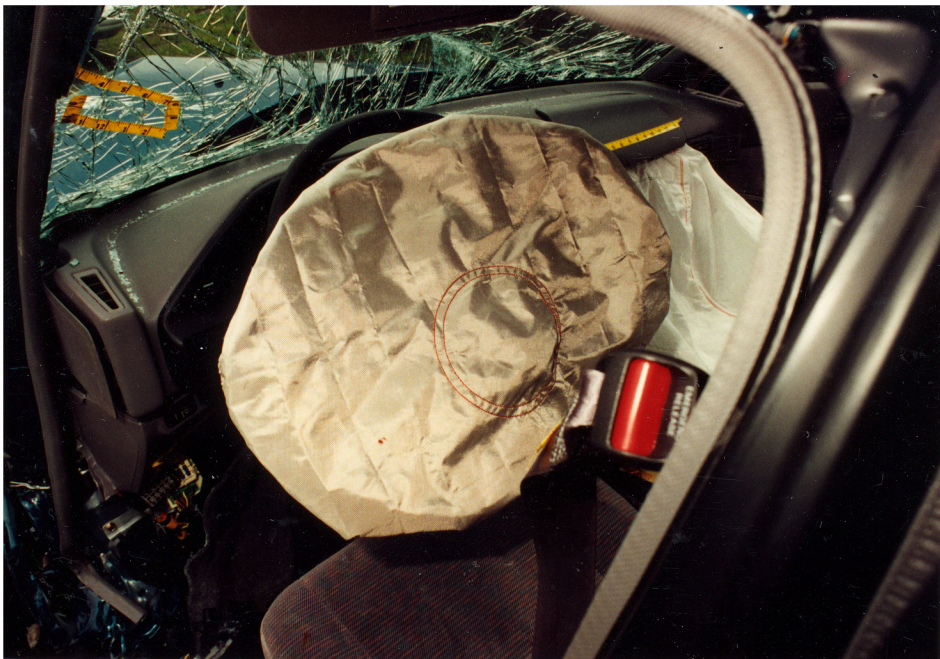
33. Overall view of the driver's compartment and the deployed air bag.

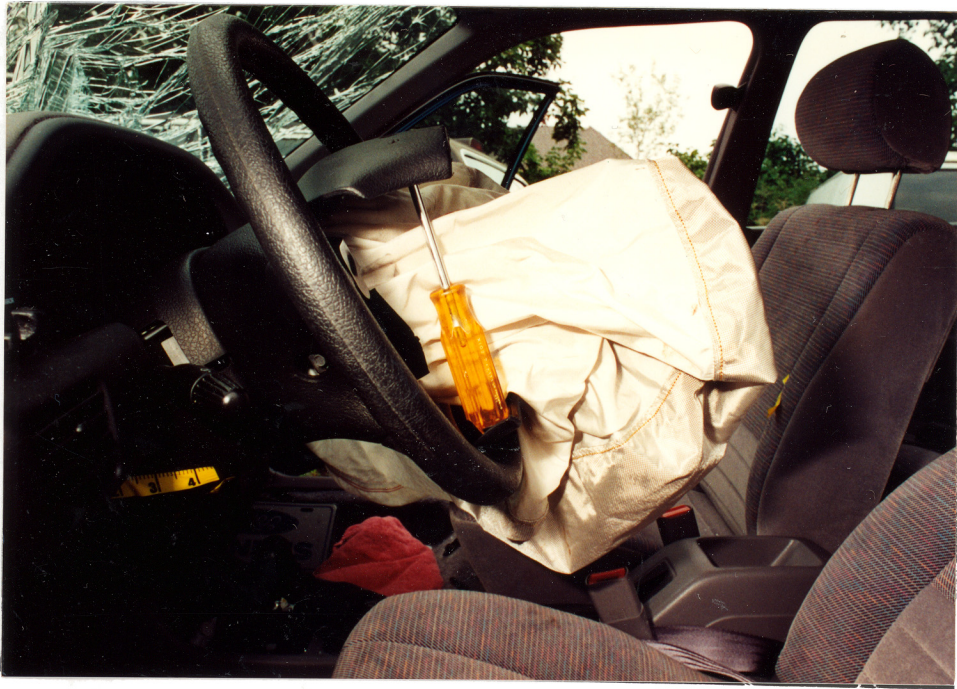
39. & 40. Perpendicular views of the driver's side air bag module cover flaps and steering assembly.

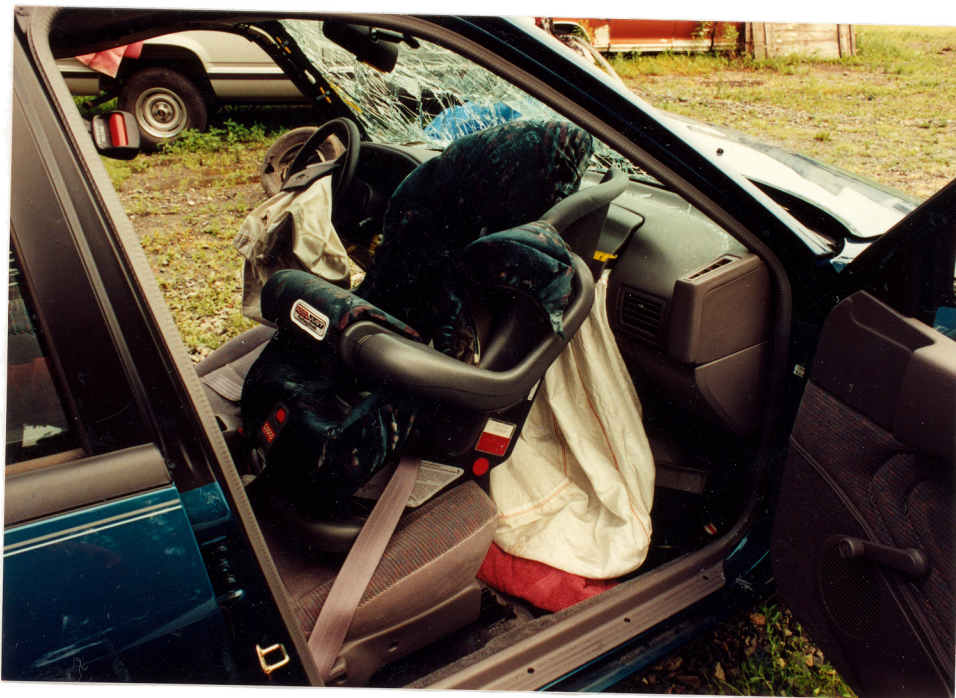
49. Position of the child restraint at the time of the crash.

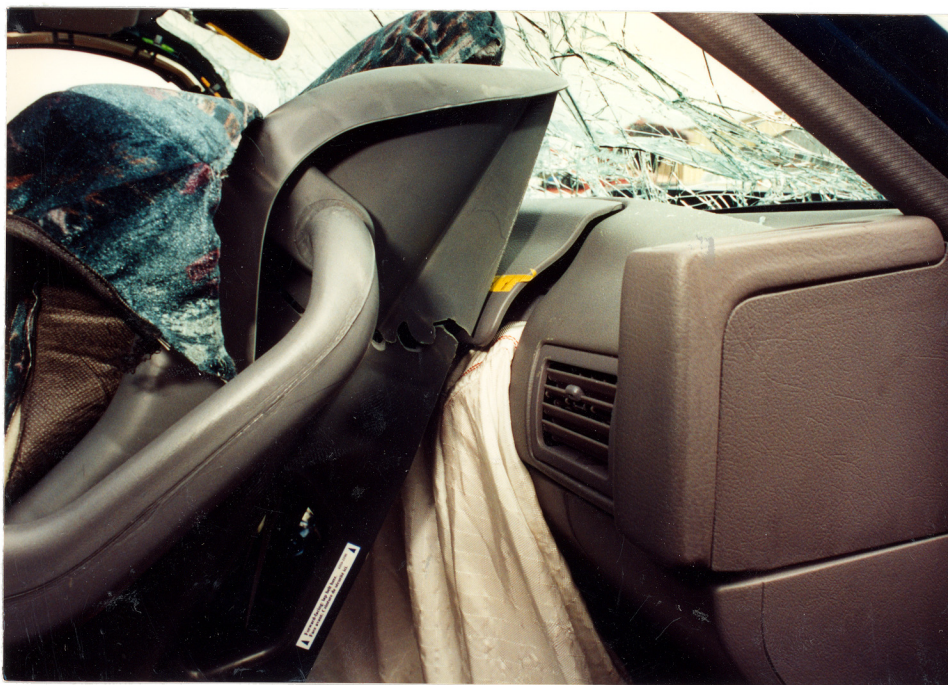
As a result of contact from the passenger side air bag module cover flap and deploying air bag, the infant sustained multiple circumferential skull fractures involving the left and right parietal bones and the occipital bone with brain matter exuding from the fracture sites, a basilar skull fracture, extensive destruction of the brain with focal areas of hemorrhage and lacerations, subdural hematoma, a contusion of the brain stem, subarachnoid hemorrhage, and subgaleal hemorrhage. These injuries qualify for a crush code (AIS-6) under the guidelines of the Abbreviated Injury Scale, 1990 Revision (AIS 90). In addition, the infant sustained a fracture of the left third rib from loading of the integral belt system or the pivoting shield.

55. Placement and fracture point of the restraint with respect to the module cover flap.

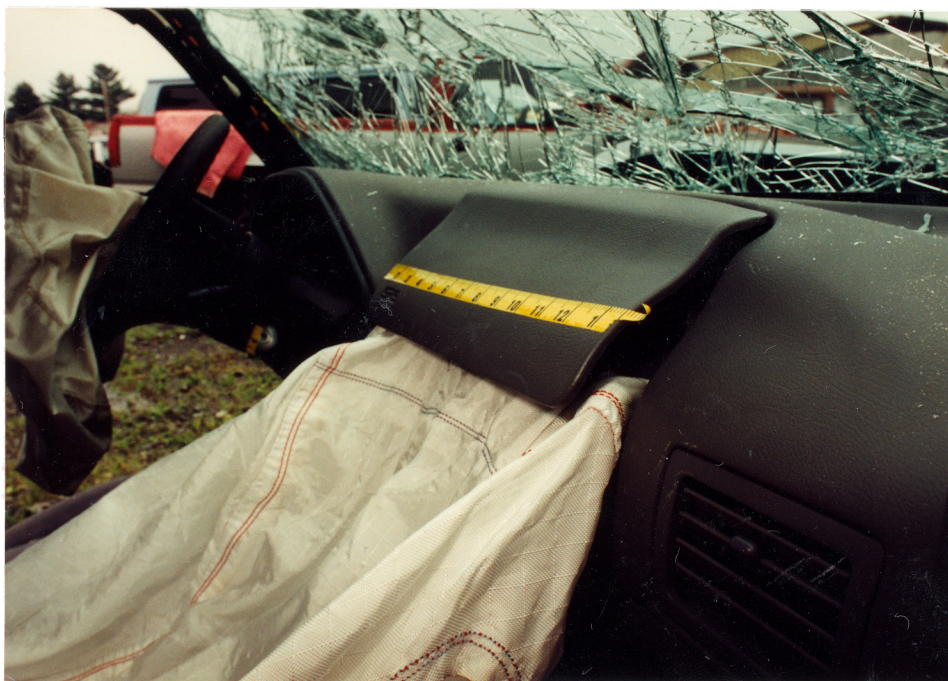
56. Vertical abrasions on the face of the flap at the parting seam.

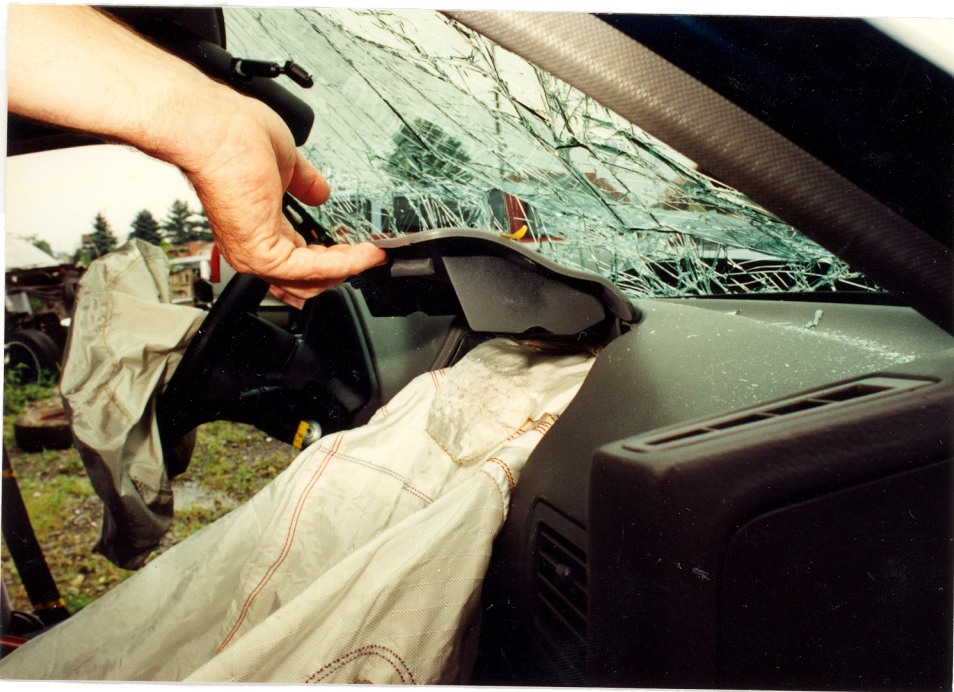
57. Top hinge point of the passenger side module cover flap.

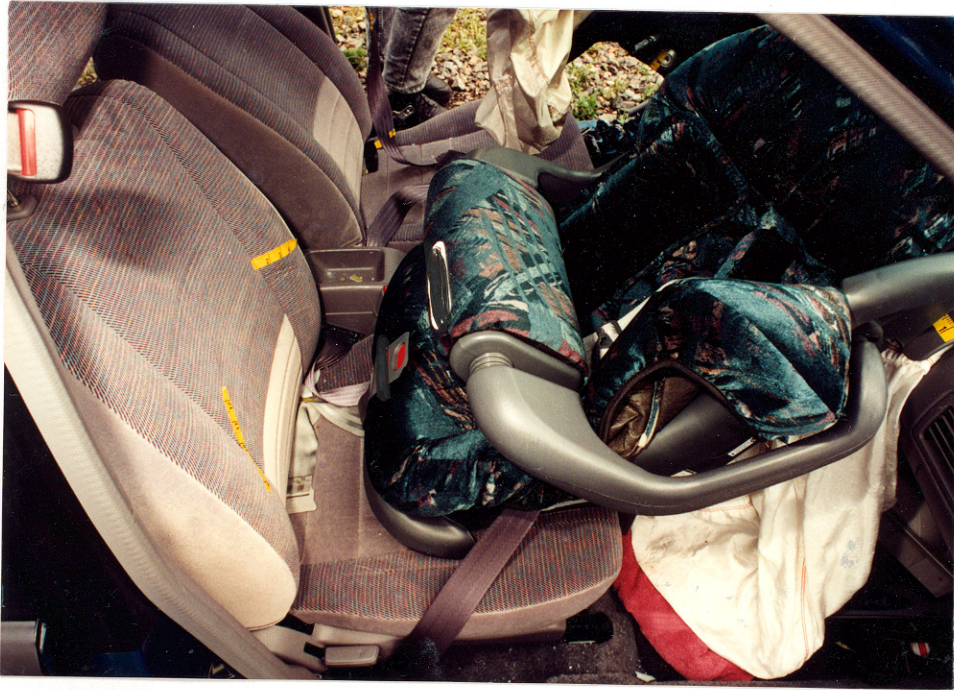
59. Circular compression imprints in the right front seat back fabric from the base of the restraint.

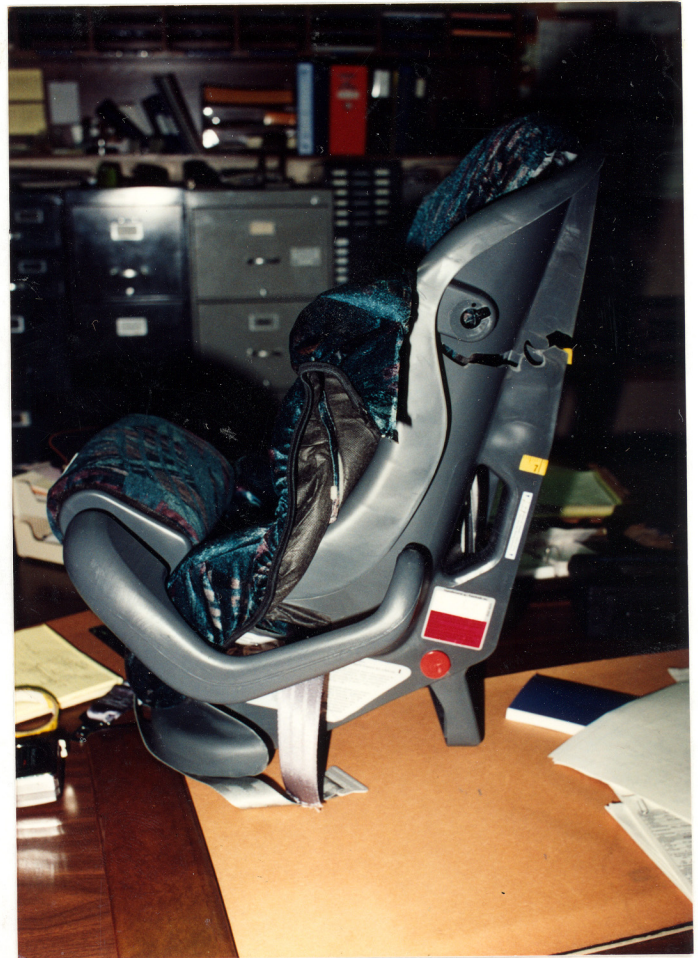
64. Left side view of the child restraint with the adjustment leg in the down and position.

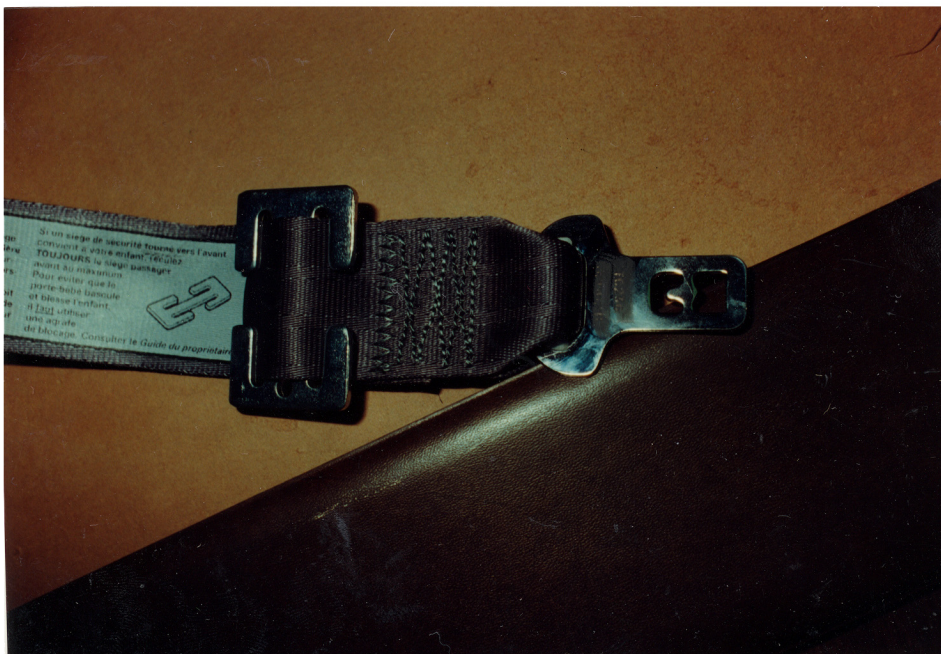
80. Placement and improper usage of the locking clip.

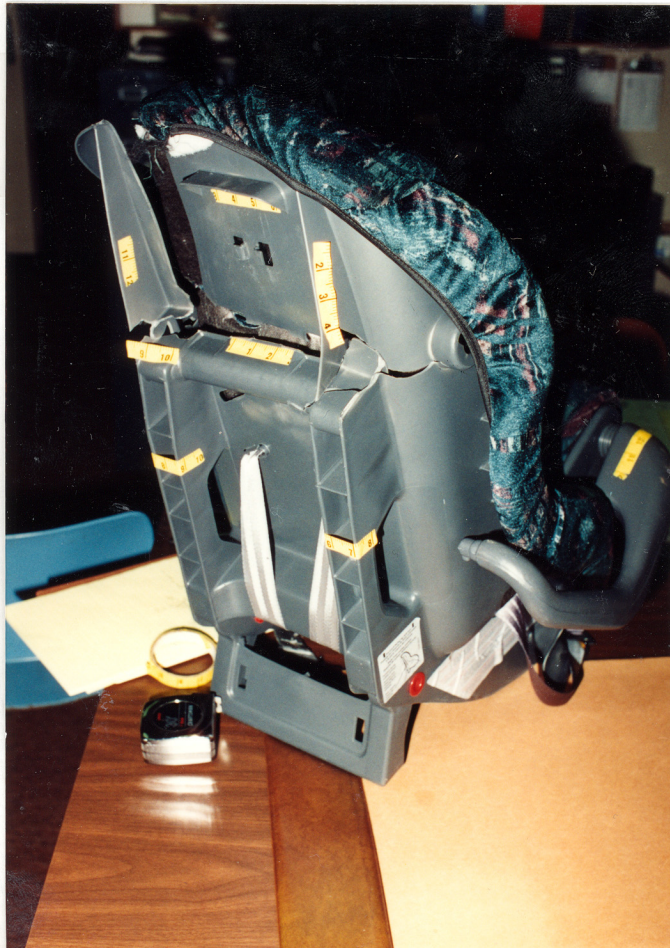
The damage to the child restraint was most visible from the back side of the restraint. Contact damage from the flap and the air bag (transfers) extended 24.8 cm (9.75") across the full width of the shell and 32.40 cm (12.75") vertically. The fracture line of the ABS shell extended 22.9 cm (9.0") across the back of the restraint at the horizontal reinforcement support and 19.3 cm (7.6") laterally across the left side of the shell and 8.6 cm (3.4") laterally on the right side to the pivot point of the shield. The fracture also extended 21.6 cm (8.6") vertically above the horizontal reinforcement to the top of the restraint at the left upper corner when viewed from the rear of the restraint. There was no separation of the ABS shell from the fractures. The padded lining of the seat was torn along the vertical fracture line at the seam.

82. Rear view of the damage to the child restraint.

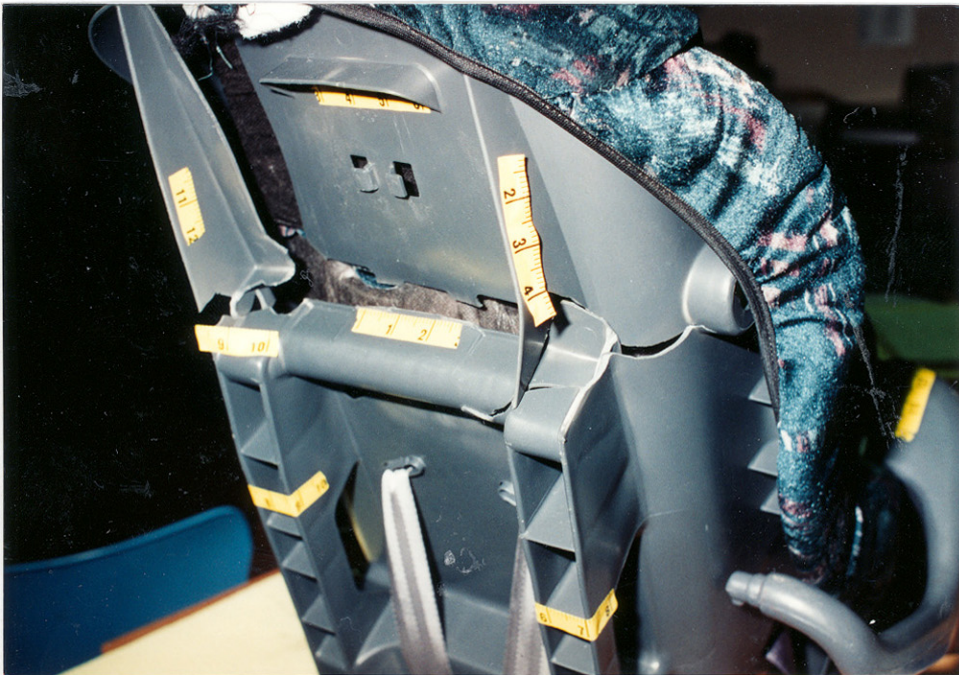
84. Contact and fracture line through the upper shell of the restraint from air bag deployment.

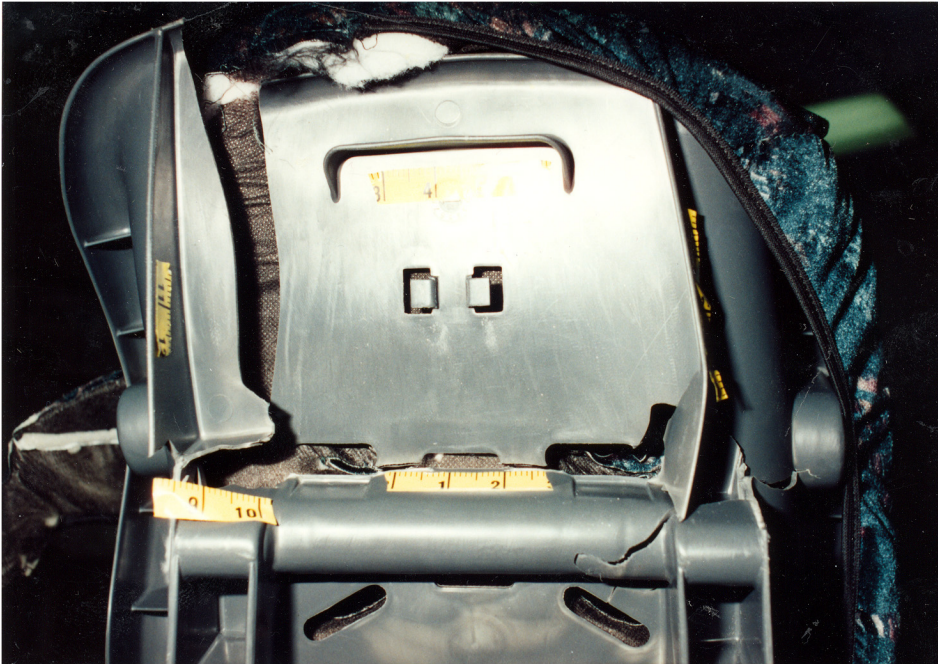
85. Vertical fracture line at the upper left quadrant of the restraint.

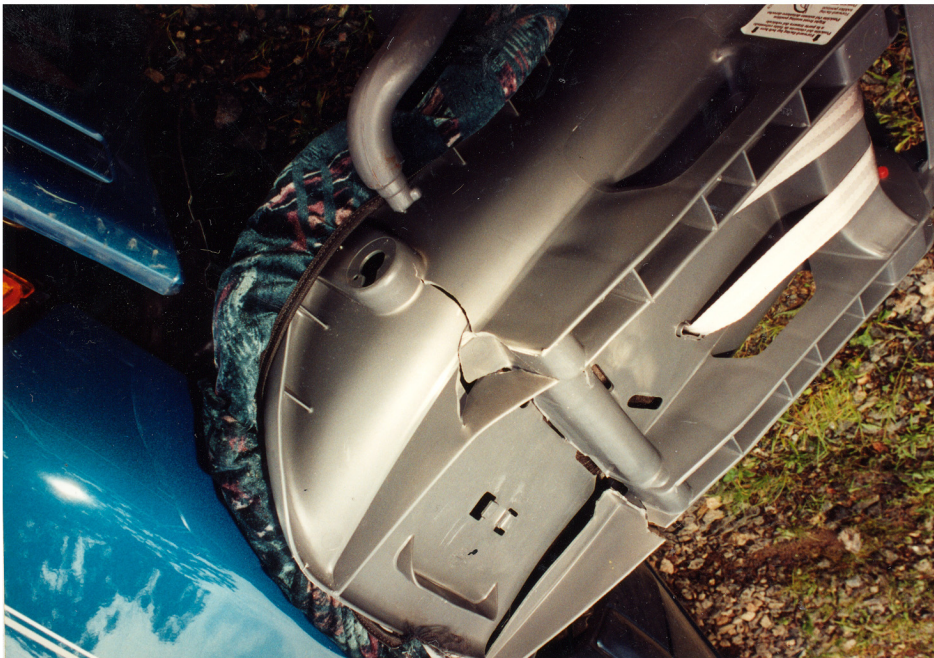
86. Fracture line through the right side of the shell ending at the shield pivot point.

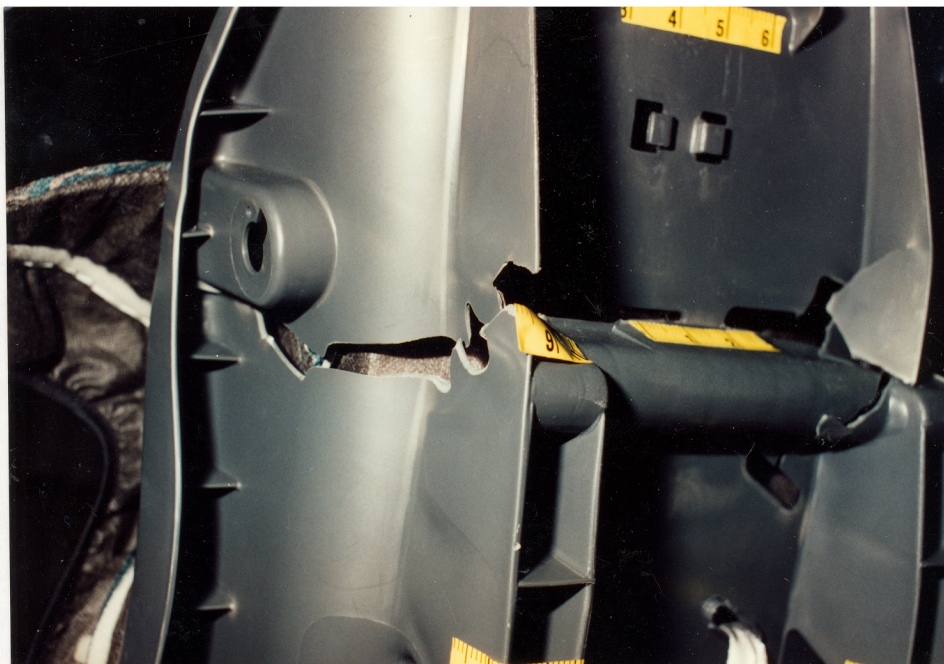
87. Air bag contact on the vertical reinforcements of the shell.

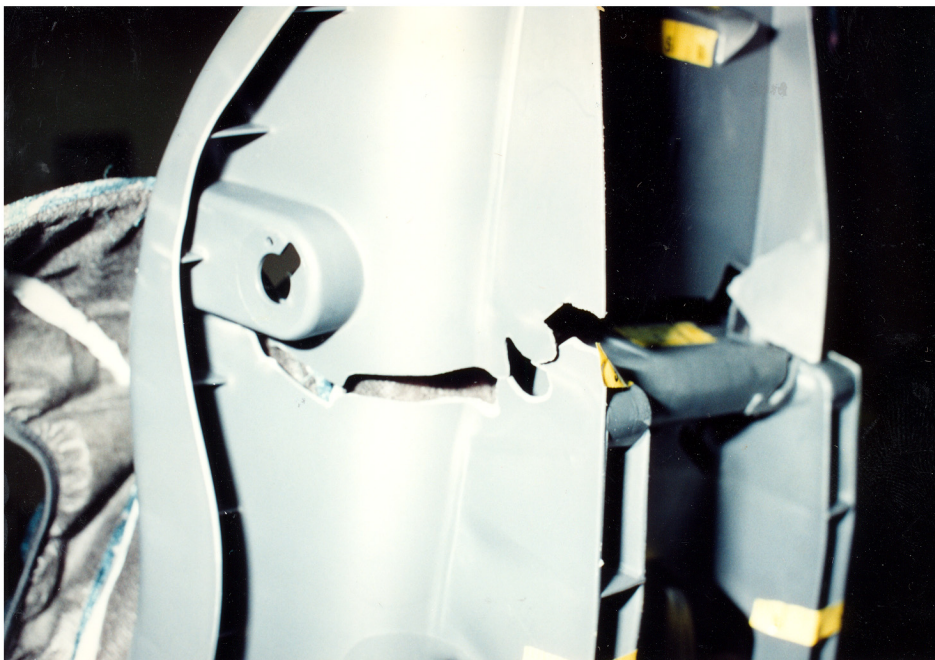
89. Close-up view of the lateral fracture line at the left side of the restraint.

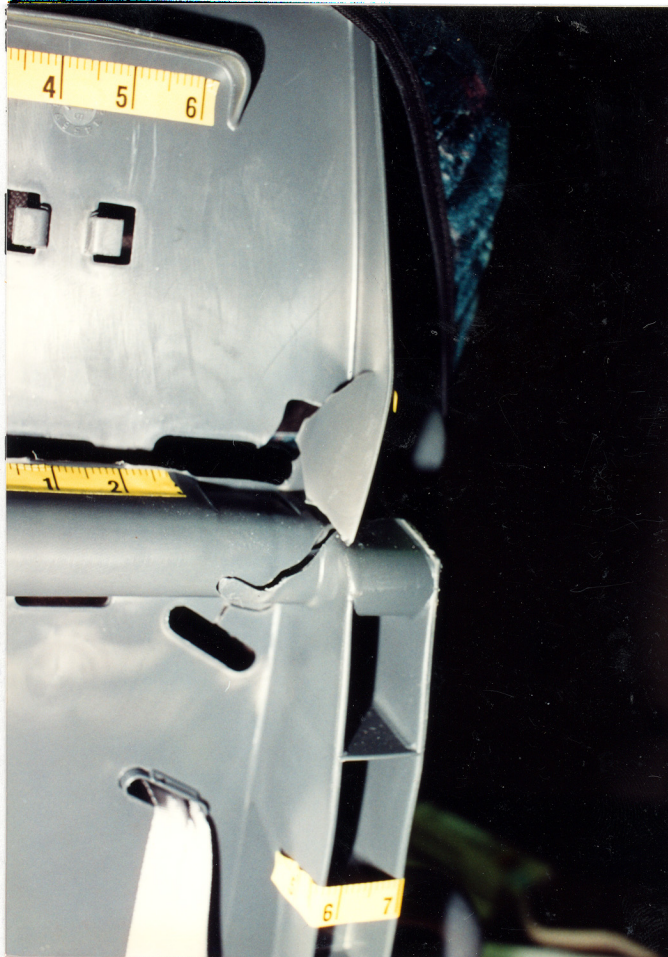
90. Flap abrasion to the right side reinforcement.

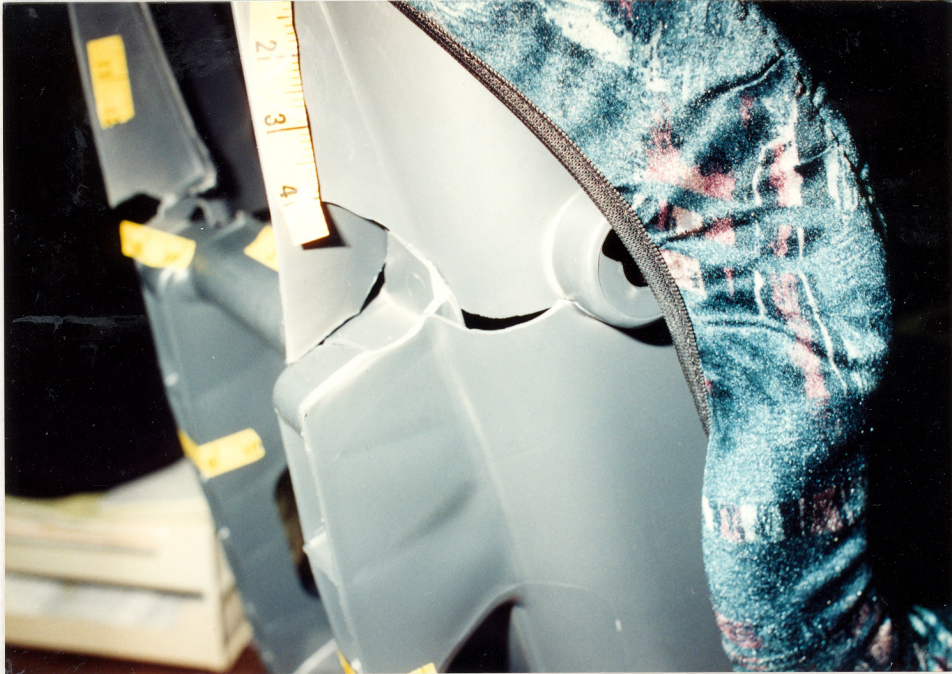
91. Close-up view of the right lateral fracture line.

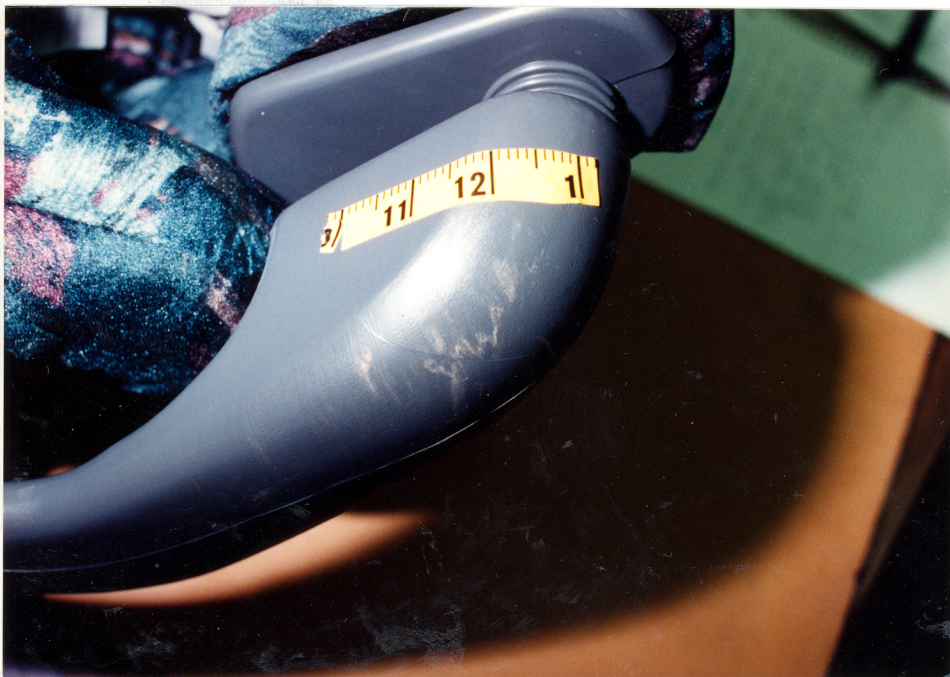
92. Abrasion/scuff mark on the right side of the shield.

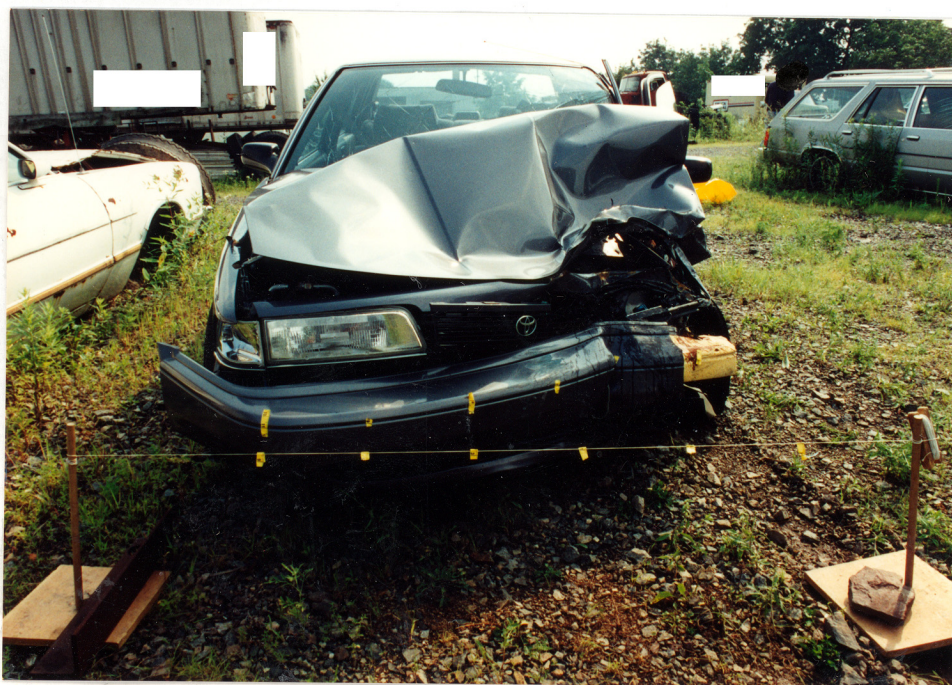
The Toyota Camry sustained moderately severe frontal damage with a maximum crush value of 67.8 cm (26.7" ) located at the left front corner of the bumper reinforcement bar. Direct contact damage from its impact sequence with the Ford Escort began 23.5 cm (9.25") right of center and extended 97.2 cm (38.25") to the left bumper corner. The off-set impacts displaced the full width of the frontal plane resulting in a combined induced and direct contact damage length of 115.6 cm (45.5"). The crush profile at bumper level was as follows:  $C_1 = 67.8$  cm (26.7"),  $C_2 = 53.6$  cm (21.1"),  $C_3 = 36.2$  cm (14.25"),  $C_4 = 20.3$  cm (8.0"),  $C_5 = 5.1$  cm (2.0"),  $C_6 = 0$  cm (0").

94. Frontal damage to the Toyota Camry.

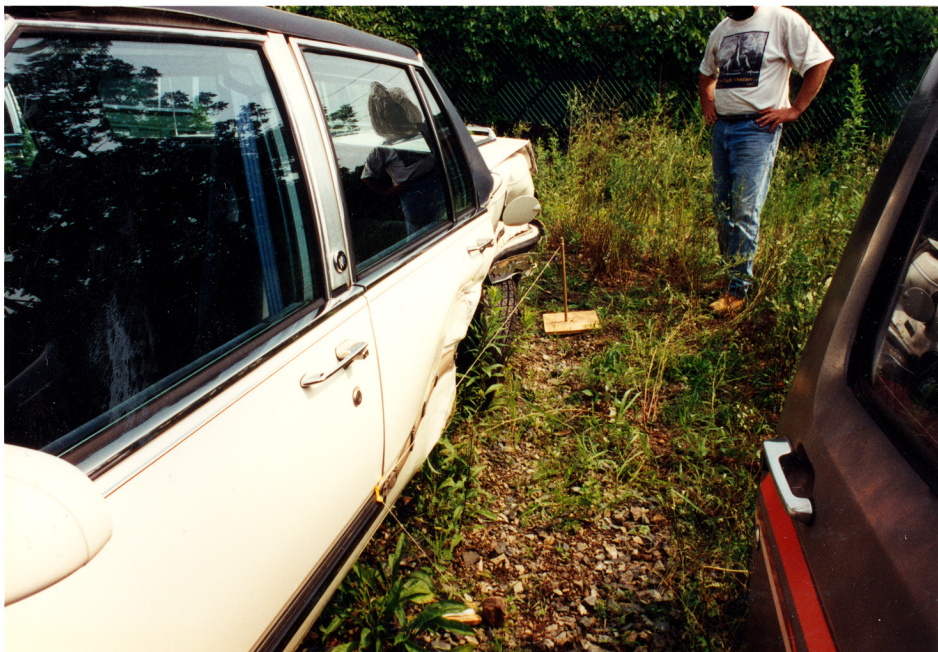
**Primary** - The 1987 Buick LeSabre sustained moderate left side damage from its initial impact sequence with the Toyota Camry. Maximum crush was 14.2 cm (5.6") located on the left quarter panel, rearward of the wheel opening. Direct contact damage began on the left rear door, 179.1 cm (70.5") rearward of the left front axle position and extended 182.9 cm (72.0") to the rear bumper corner. The combined induced and direct contact damage was 227.3 cm (89.5") which extended from the B-pillar to the bumper corner. Crush values at bumper level were as follows: C1= 5.1 cm (2.0"), C2= 14.2 cm (5.6"), C3= 13.0 cm (5.1"), C4= 12.1 cm (4.75"), C5= 5.1 cm (2.0"), C6= 0 cm (0.0").

104. Left side damage from the impact sequence with the Toyota Camry.

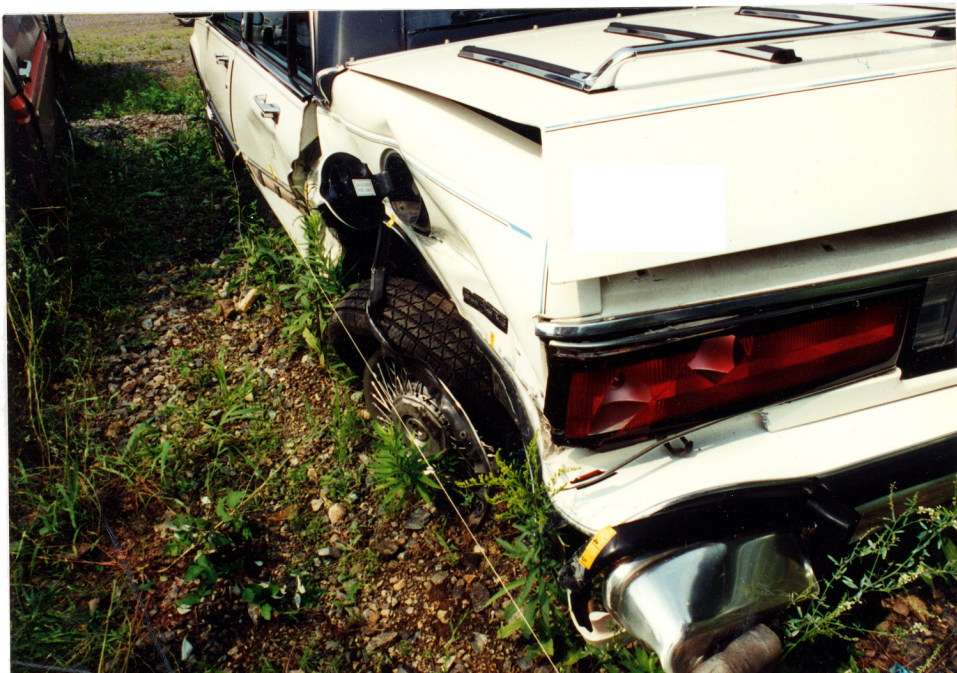
105. Extent of left side crush.

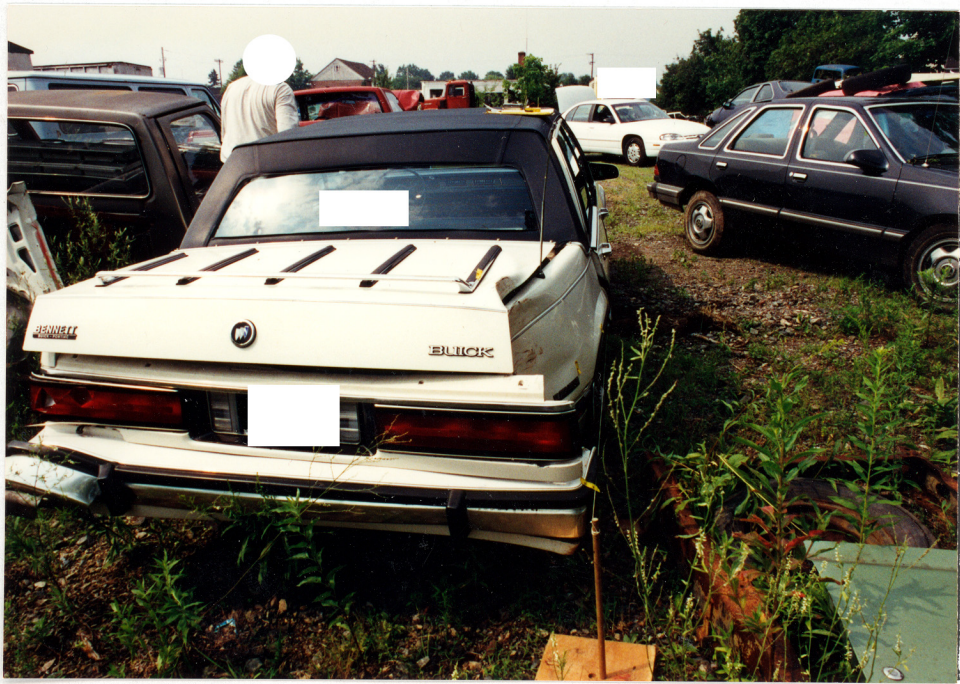
107. Right rear three-quarter view of the pole impact damage.
